Manhole Inspection Summary

Manhole # S37AA1011MH

Location Address: **500 35TH ST**

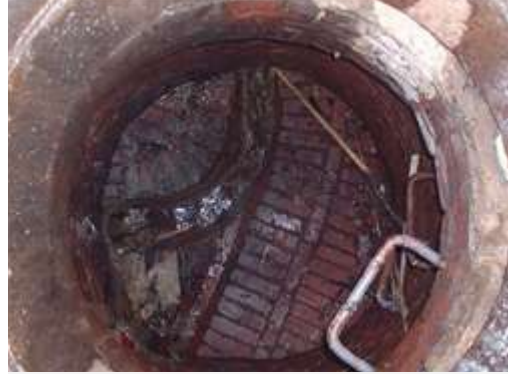
Top View

Corroded steps. Bench and Channel debris.

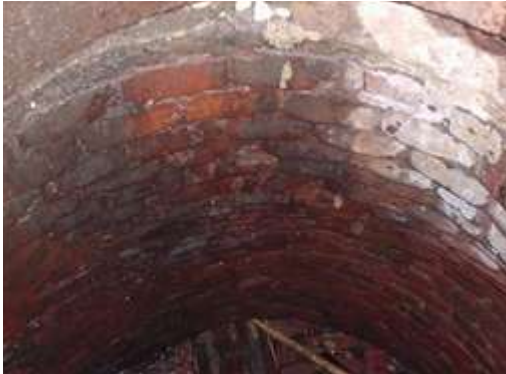
Defect

Frame leaks. Frame offset. Adjustment deterioration and infiltration. Corbel and Barrel infiltration.

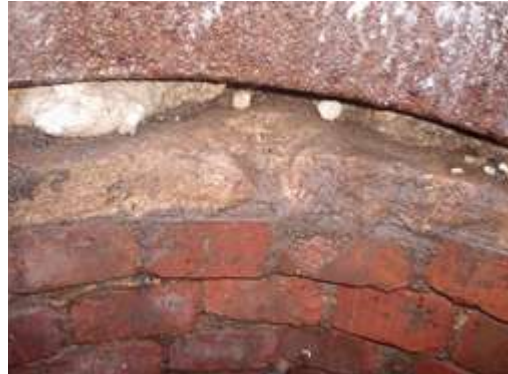
Defect

Frame leaks. Adjustment deterioration, loose brick and infiltration.

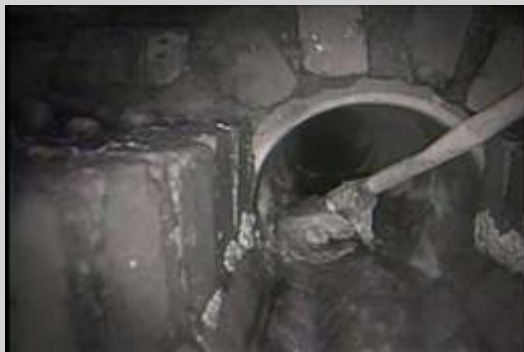
8 in. Circular Gravity Sewer Pipe Out @ 12 O'Clock

Deposits: ☐ None ☐ Mud ☐ Sludge ☒ **Debris** ☐ Grease

Silt Depth: **0** (in.) Deposits Extent: **Light**

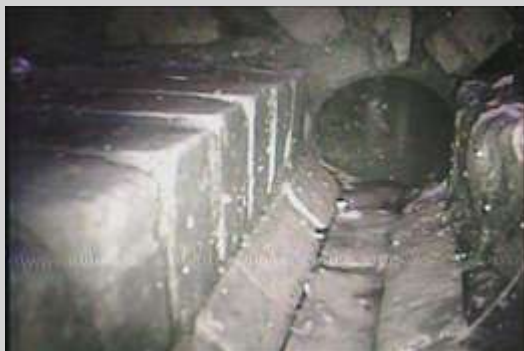
6 in. Circular Gravity Sewer Pipe In @ 7 O'Clock

Channel deterioration.

Infiltration: **None** Pipe Seal Cond: **Cracked**

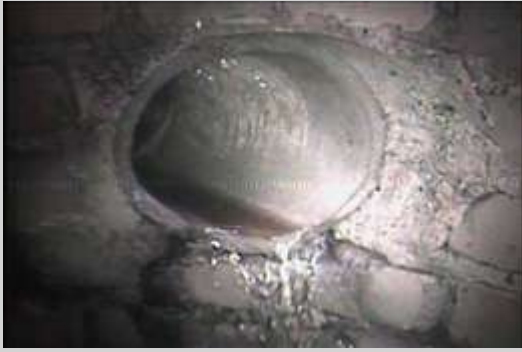
Pipe In @ 8 O'Clock

Deposits: ☒ None ☐ **Mud** ☐ Sludge ☐ Debris ☐ **Grease**

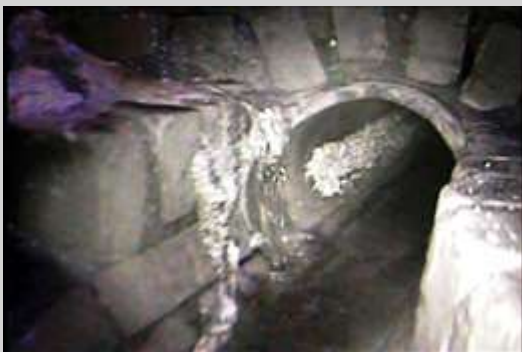
Pipe In @ 9 O'Clock

Deposits: ☐ None ☒ **Mud** ☐ Sludge ☐ Debris ☒ **Grease**

Silt Depth: **0** (in.) Deposits Extent: **Light**
